Characteristics and microstructure in the evolution of shear localization in Ti–6Al–4V alloy

Yilong Bai^a, Qing Xue^a, Yongbo Xu^b and Letian Shen^a

^a *Laboratory for Non-linear Mechanics of Continuous Media, Institute of Mechanics, Chinese Academy of Sciences, Beijing, 100080, China*

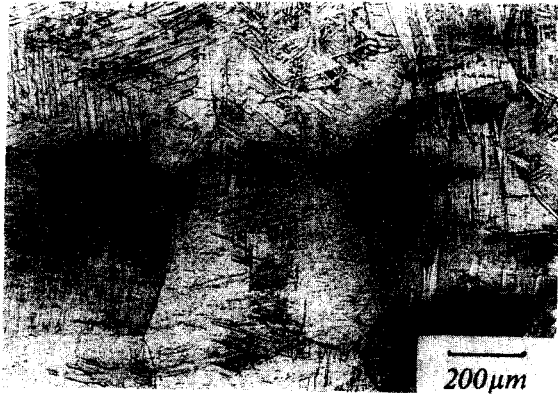
Fig. 4. Optical micrograph of structure of treated Ti-6Al-4V alloy.

A hot-rolled Ti-6Al-4V alloy was tested in the present study. Its chemical composition is shown in Table 1. The hot-rolled bar was treated as a solid solution i.e. annealed at 980°C for one hour and then air-cooled. Its microstructure appears to be laminar $\alpha + \beta$ phase colonies (Fig. 4).

Within the β phase there are grain of about 400 μm , while groups of α phase keep the uniform orientation.

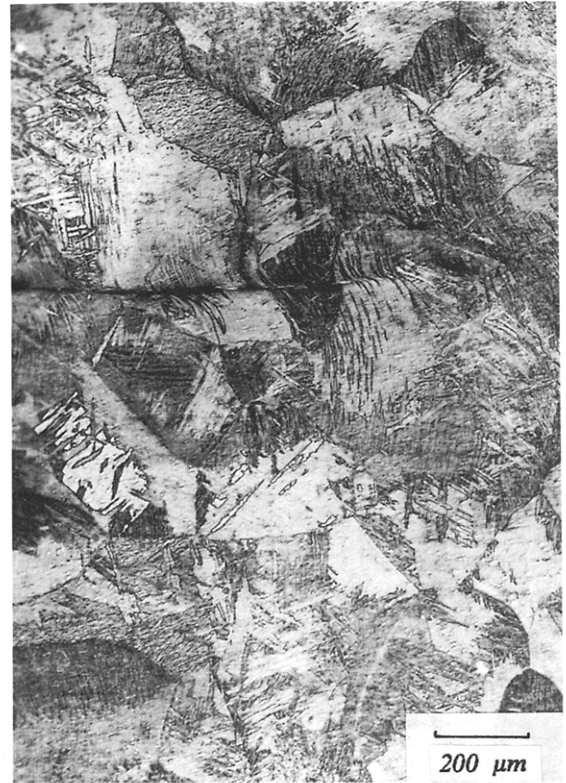
Fig. 8. Shear band with voids and microcracks.

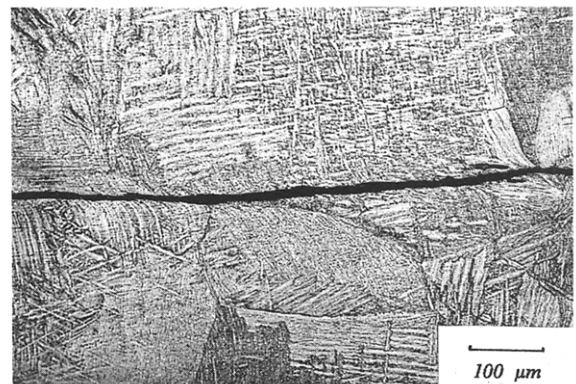
Fig. 9. Coalescence of microcracks in localized zone.

ence of the shear band (Marchand and Duffy, 1988). However, the comparative examination of T9-39, 37, 21 and the τ - γ curve (Fig. 6) seems to us that the decisive mechanism governing the loss of load-carrying capacity is the shear band induced successive coalescence of microcracks
